MAY NEWS:

THERMAL STRESS GLASS BREAKAGE

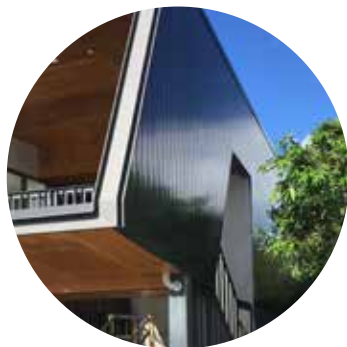
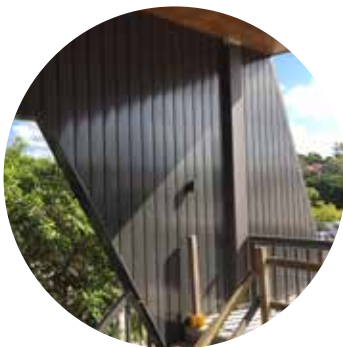
This project was featured in our January Newsletter and the vertically applied Ultraclad Shadowline UA6478 cladding is now complete. Still a couple of odds and ends to be finalised before the building is complete.

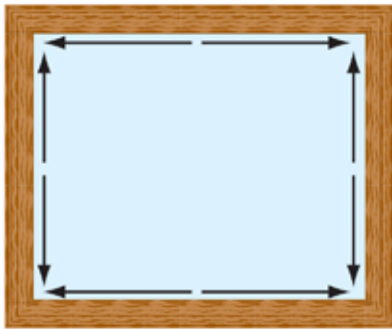
Figure 3 The edges are then under stress to expand, this equals thermal stress. If this thermal stress meets or exceeds the breaking strength of the glass, thermal stress fracture of the glass pane occurs.

Solar energy is the major cause of temperature difference in glass; the process of thermal stress breakage is shown in figures 1 to 3.
