HINGED DOOR 2375 x 1500

Test 0103 04/08/2011

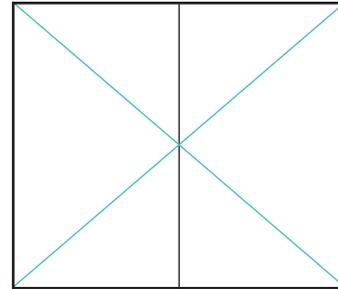
Construction:

Sill	WAFD111
Head	WAFD112
Head Bead	WAFD113
Jamb	WAFD112
Jamb Bead	WAFD113
Stiles	WAWF006
Rails	WAWF006
Bead	WAWF008

Test	Standard	Result
Deflection (stile 1)	Positive	AS4420.2	Span/502 @ 1500Pa
	Negative	AS4420.2	Span/677 @ 1528Pa
Deflection (stile 2)	Positive	AS4420.2	Span/192 @ 1500Pa
	Negative	AS4420.2	Span/193 @ 1528Pa
Deflection (stile 3)	Positive	AS4420.2	Span/401 @ 1500Pa
	Negative	AS4420.2	Span/602 @ 1528Pa
Operating force	Open - initiating	AS4420.3	N/A
	Open - maintaining	AS4420.3	N/A
	Close	AS4420.3	N/A

Test	Standard	Result
Air infiltration	Positive @ 75Pa	AS4420.4	0.22l/S/M ²
	Negative @ 75Pa	AS4420.4	0.42l/S/M ²
	Positive @ 150Pa	AS4420.4	0.32l/S/M ²
	Negative @ 150Pa	AS4420.4	0.66l/S/M ²
Water penetration resistance		AS4420.5	150Pa
Ultimate strength	Positive	AS4420.6	4386Pa
	Negative	AS4420.6	6105Pa
